Accident Data

Device S/N: G60020CE3BCF

Device Model: Geotab GO6

Date of Analysis: 30/October/2017

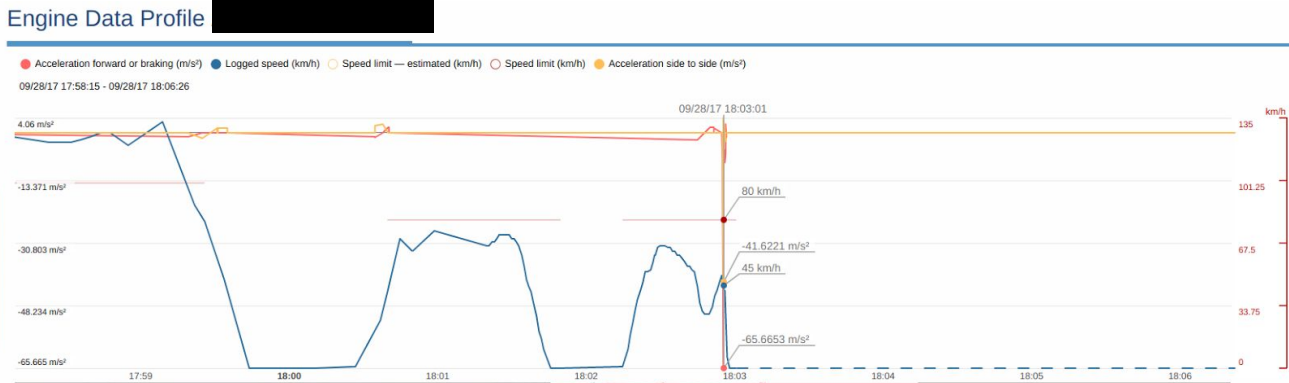
Figure 2: Acceleration Forward and Braking, and Acceleration Side to Side Graphs

It can be seen in Figure 2 that at 18:03:01 EDT the telematics device measured a peak right side acceleration of -41.6586 m/s^2 followed shortly after by a peak negative forwards acceleration of -65.6653 m/s^2 . Afterwards, the telematics device measured a peak negative forwards acceleration of -21.5354 m/s^2 at 18:03:01 EDT which was followed by a peak right side acceleration of -11.4737 m/s^2 . The telematics device then registered a peak negative forwards acceleration of -8.4729 m/s^2 at 18:03:02 EDT. This event indicates a heavy negative forwards acceleration followed shortly after by a heavy right side acceleration experienced by the telematics device. The first peak represents the accident level event that was detected by the telematics device.

- Acceleration side to side. Negative is right and positive is left.
- Acceleration forward or braking. Positive is forward and negative is backwards acceleration.

- Accident level event is defined as an acceleration greater than 24.5 m/s^2 in the forward/reverse or side to side direction. This is a system level threshold that is set on the internal firmware of the device.

- Accidents are detected by the GO device upon any acceleration greater than or equal to 2.5 G where G is the gravitational constant of 9.81 m/s^2 . The firmware will not use accelerometer Up/Down (aka Z axis) in this calculation. The calculation uses the magnitude of the hypotenuse between X and Y ($\sqrt{X^2+Y^2}$) Where X is Forward/Braking and Y is Side to Side.

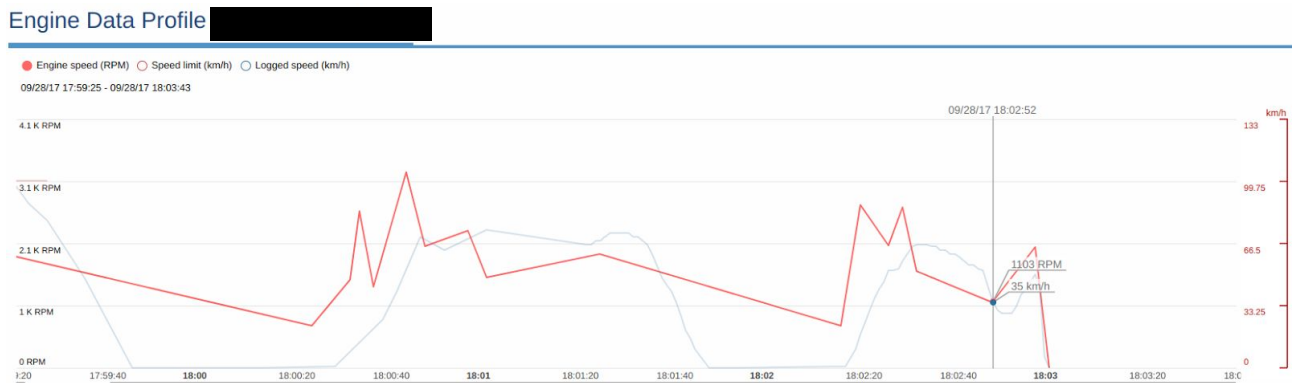
Figure 3: Engine Speed (RPM)

In Figure 3 at 18:02:52 EDT the telematics device measured the engine speed (RPM) as 1082.75. At 18:03:01 EDT the RPM had increased to 2008.5 RPM, which then decreased to zero RPM at 18:03:04 EDT. This indicates that the RPM was decreasing at the time of the accident level event.

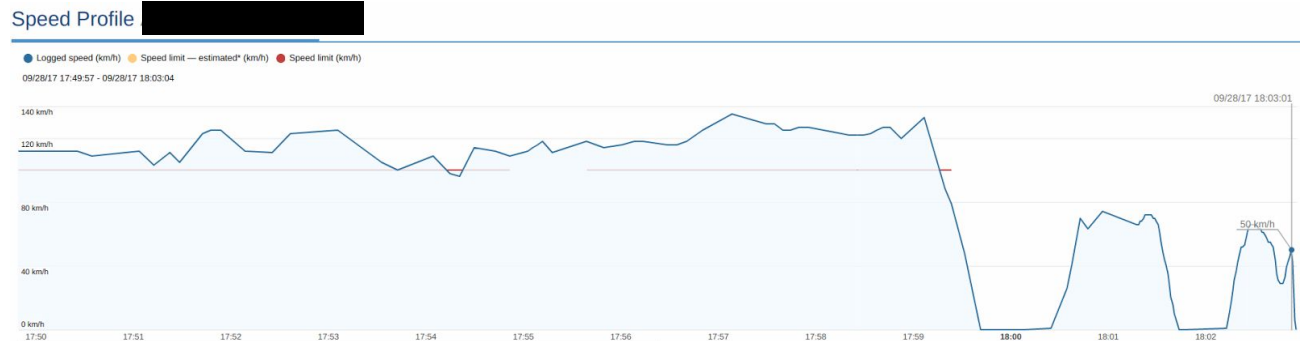
Figure 4: Speed Profile

Figure 4 is a speed profile indicating the speed logged from the telematics device during the time period of the accident level event. The blue lines indicate the device's speed. Red lines indicate a confirmed posted road speed. The telematics device reported the speed as 50 km/h at 18:03:01 EDT before decreasing to 42 km/h at the time of the accident level event at 18:03:02 EDT before decreasing further to 6 km/h at 18:03:03 EDT. The telematics devices reported the vehicle reached a 0 km/h speed at 18:03:04 EDT.

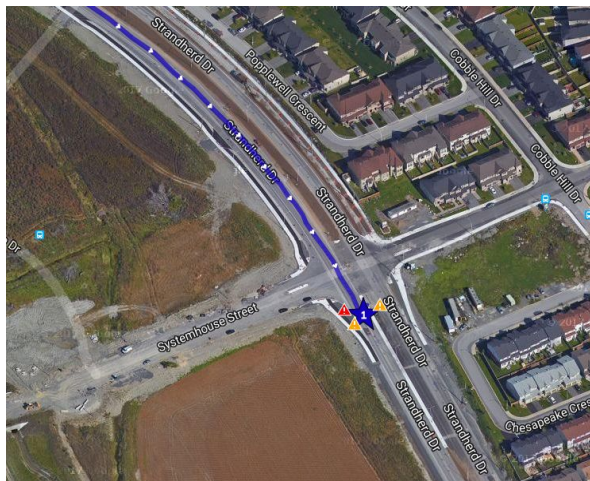
Figure 5: Device Trip Map

Figures 5 through 7 indicate the location of the accident level event as the device detected movement at 18:03:02 EDT on Strandherd Dr. The approximate location of the accident level event was at 45.26868 latitude, -75.78009 longitude at 18:03:02 EDT (4175 Strandherd Dr, Nepean, ON K2J, Canada). At 18:03:03 EDT the device next registered a GPS location of 45.26865 latitude, -75.78006 longitude (4175 Strandherd Dr, Nepean, ON K2J, Canada) followed by a GPS location of 45.26865 latitude, -75.78006 longitude (4175 Strandherd Dr, Nepean, ON K2J, Canada) where a 0 km/h speed was detected at 18:03:04 EDT.
